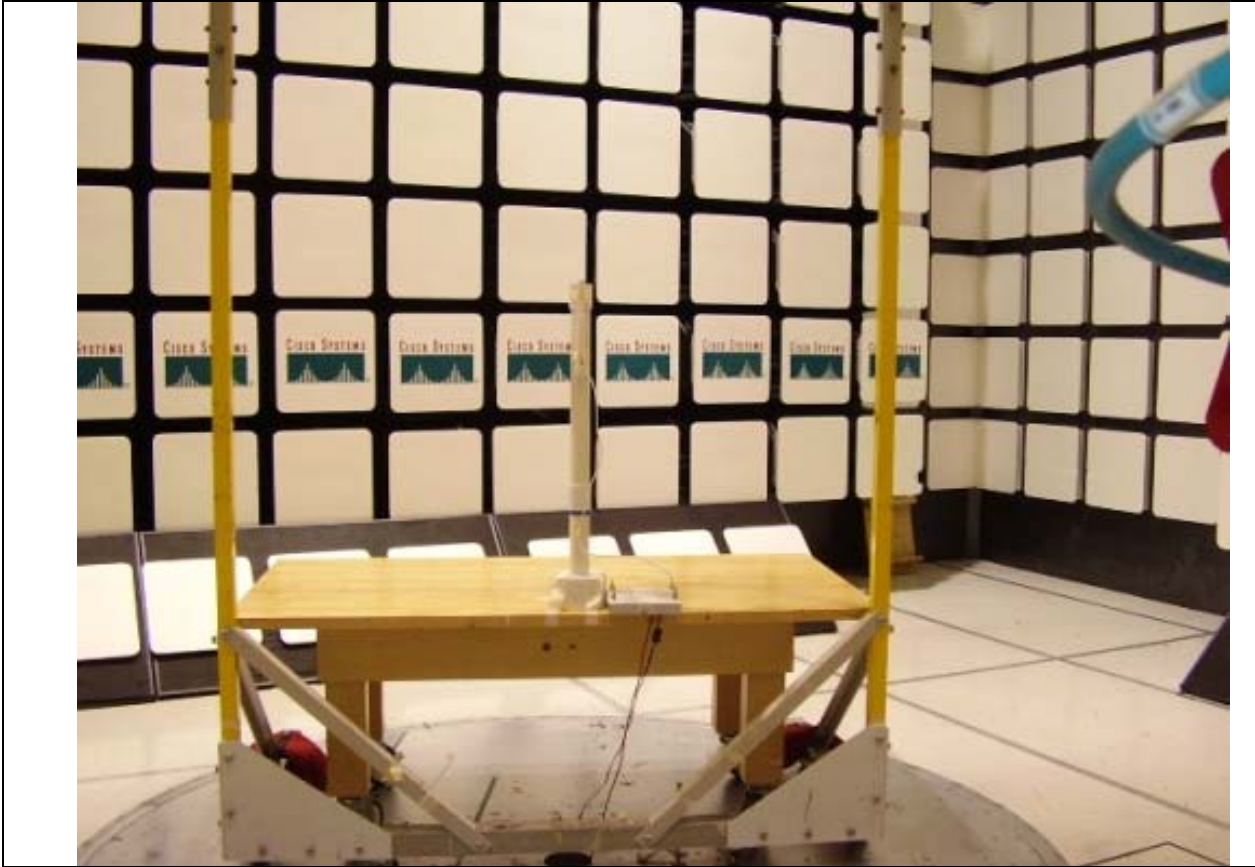
Title: 5.2dBi Omni Antenna Test Setup

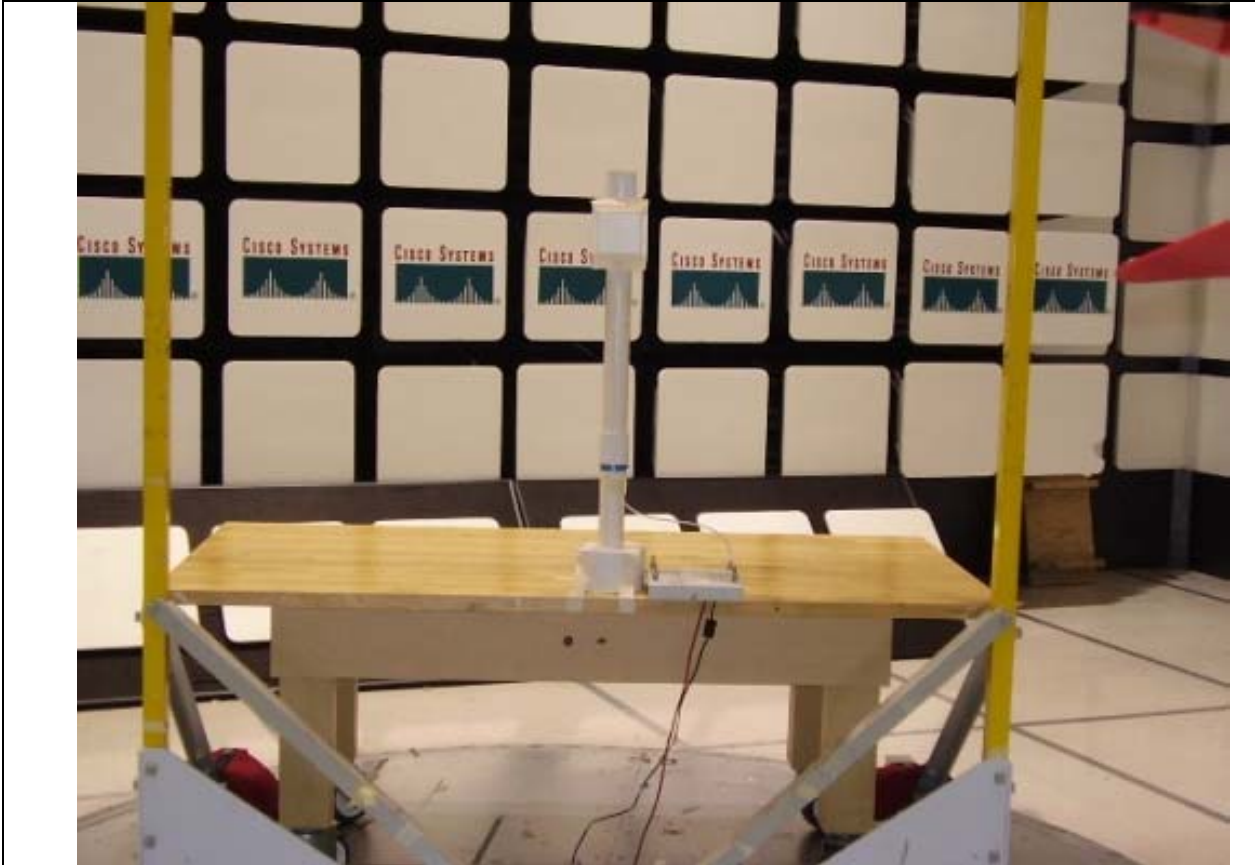
Title: 9.5dBi Patch Antenna Bandedge Setup

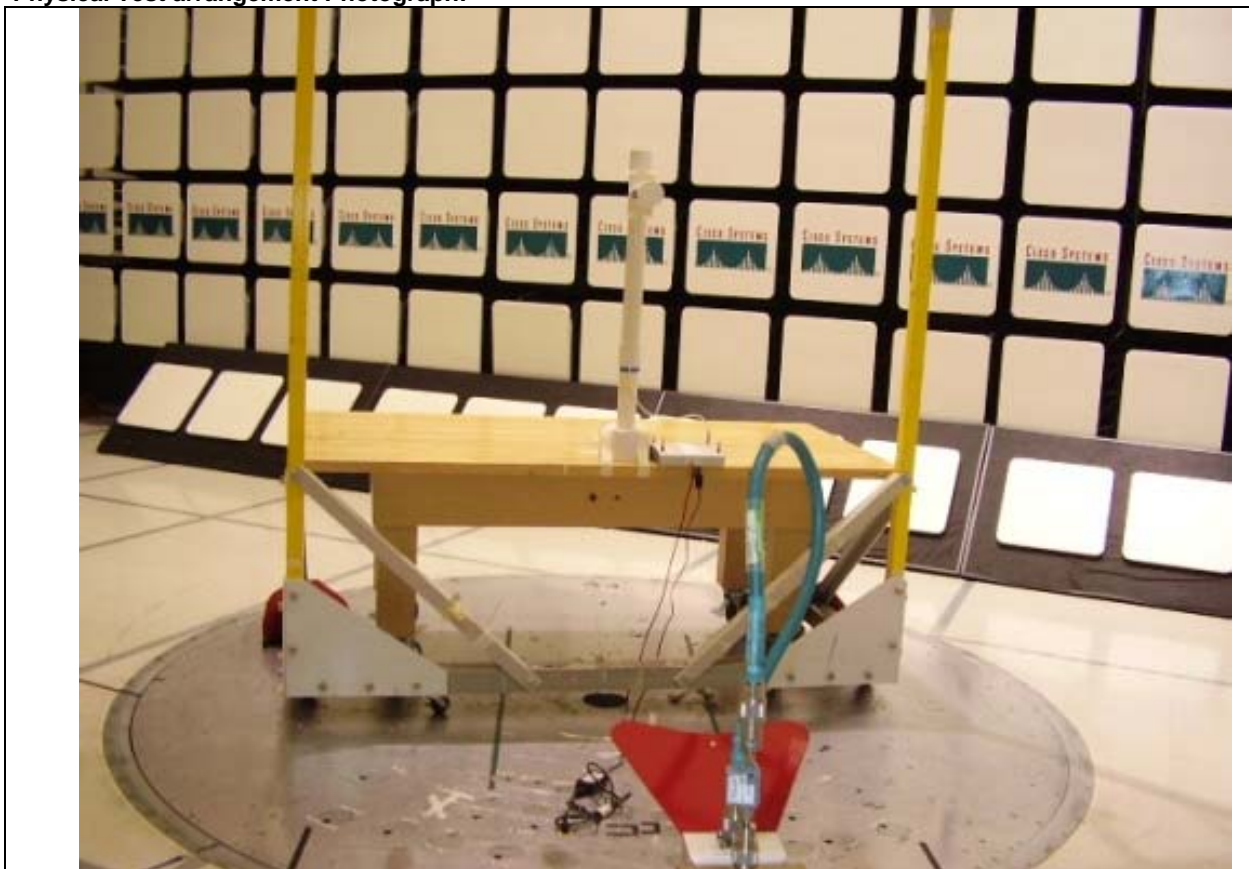
Title: 10dBi Band Edge Test Setup

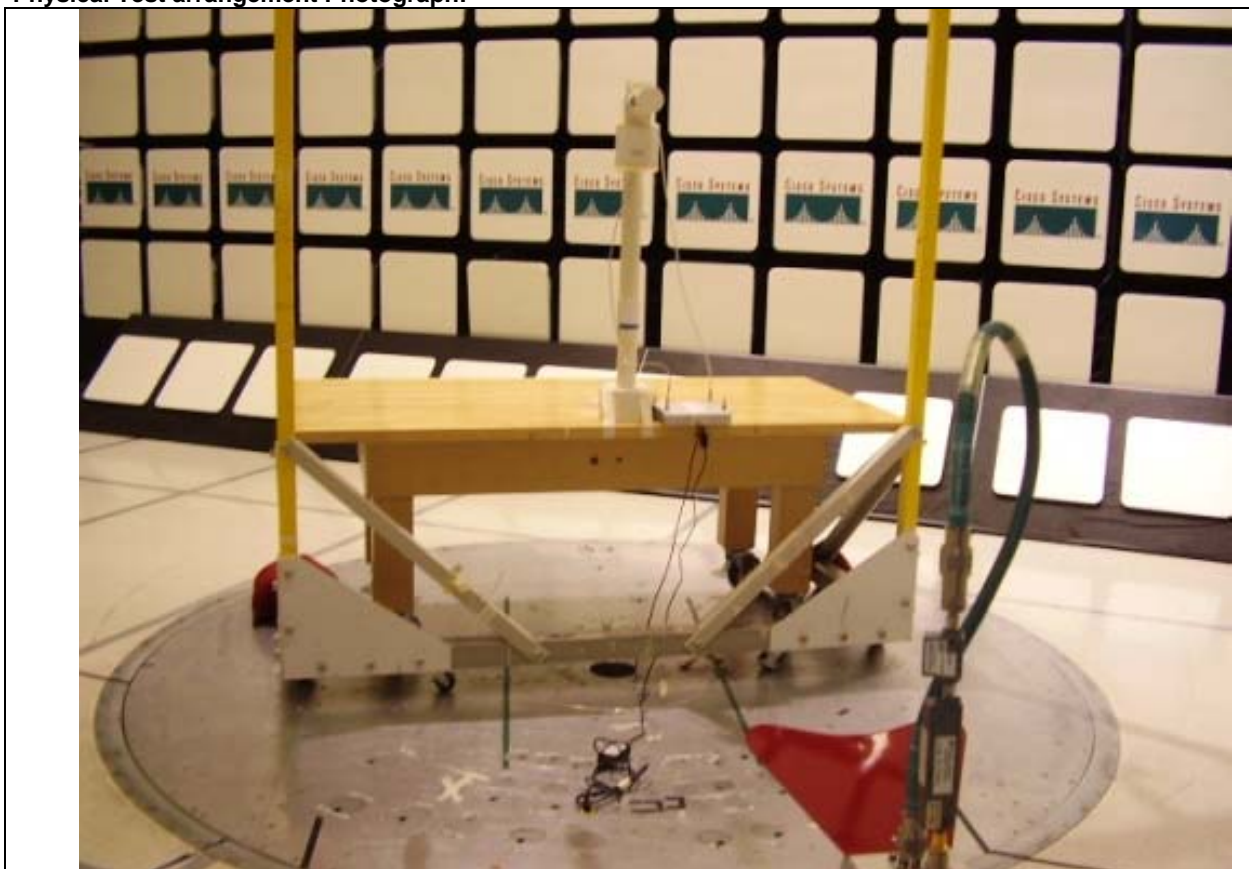
Title: Colocation Test Configuration

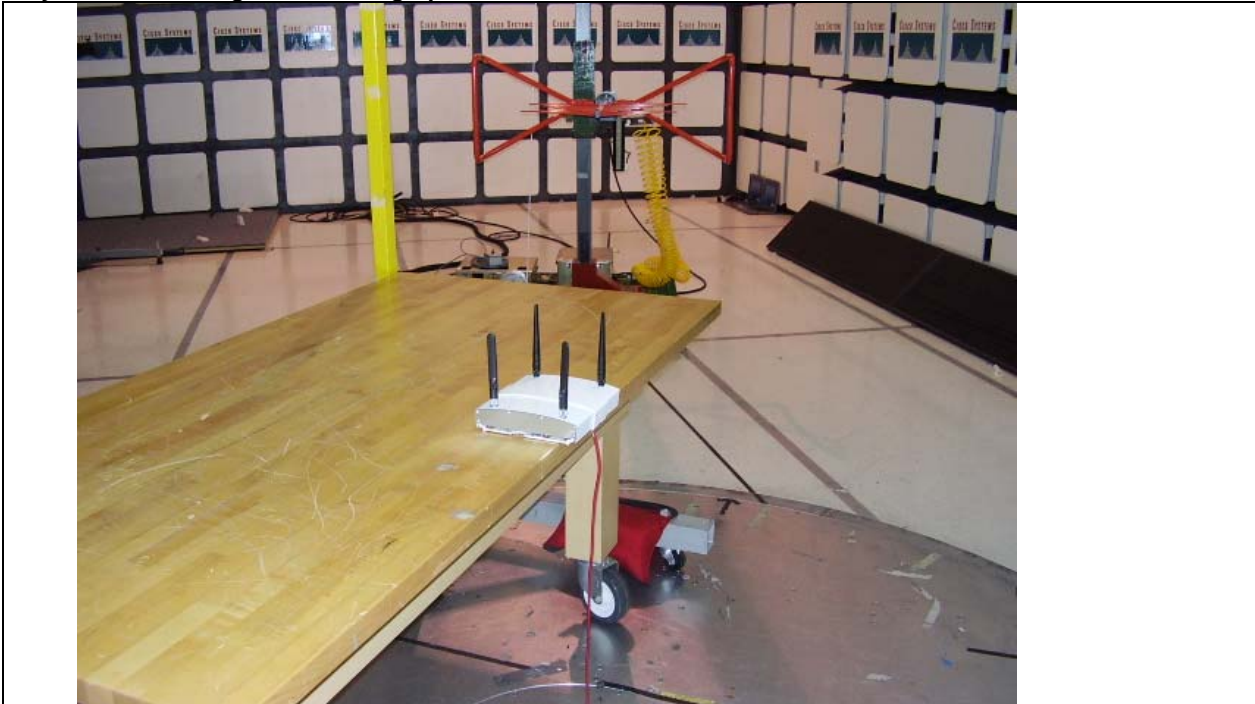
Title: Radiated Setup

Bilog antenna in background used to measure 30Mhz to 1Ghz range.

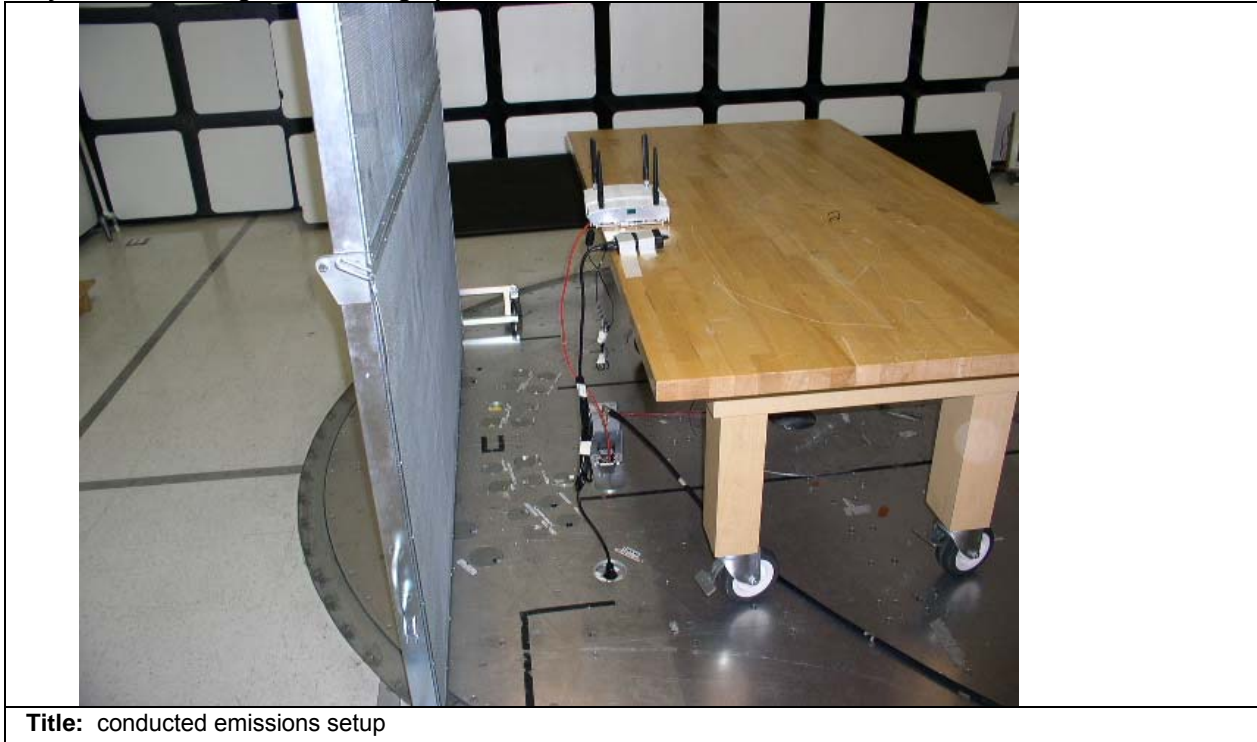
Power supply plugged into LISN mounted under Turntable.
