**Prufbericht-Nr: 18121105.f01**  
*Test report No: 18121105.f01*

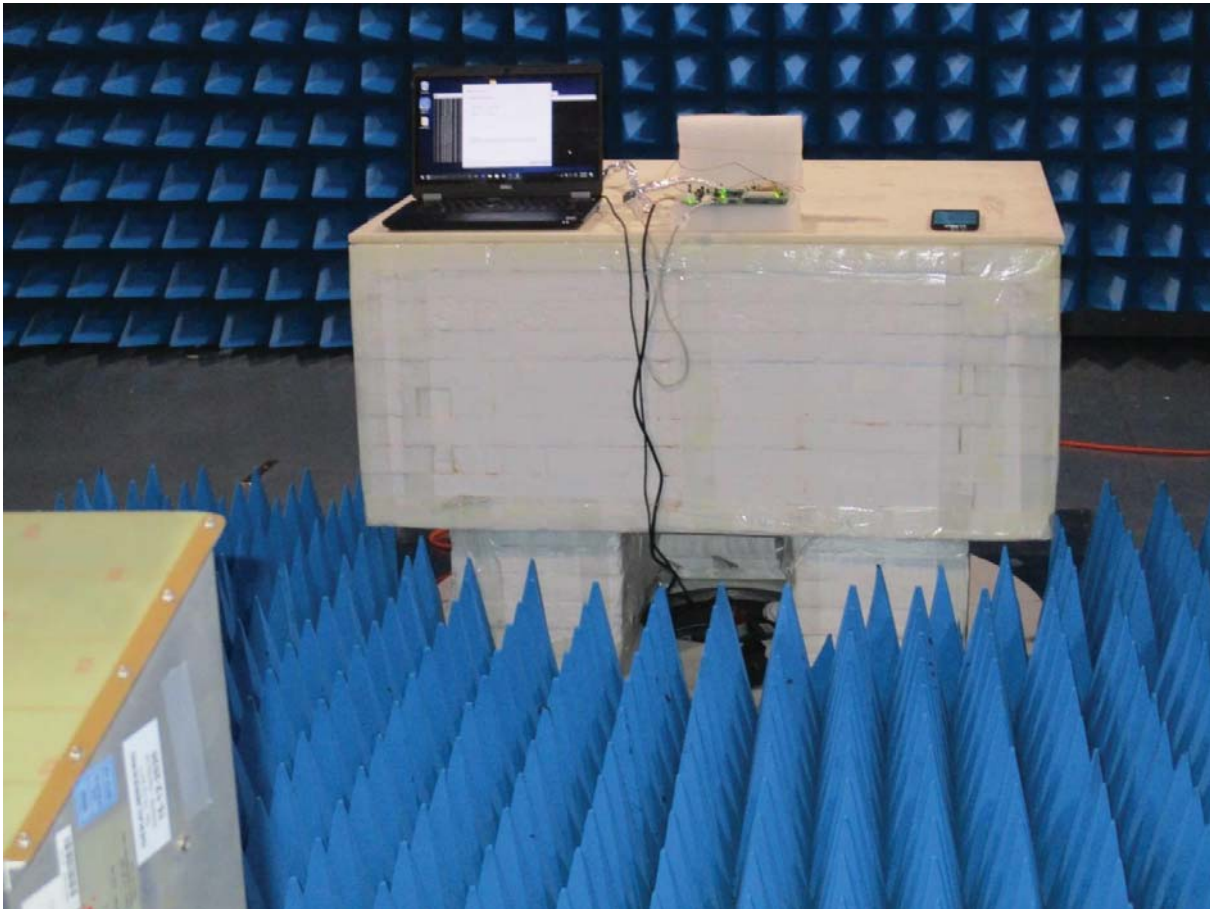
Photograph test setup 1- 6 GHz

*Photo 2: Photograph radiated emissions 1 – 6 GHz*

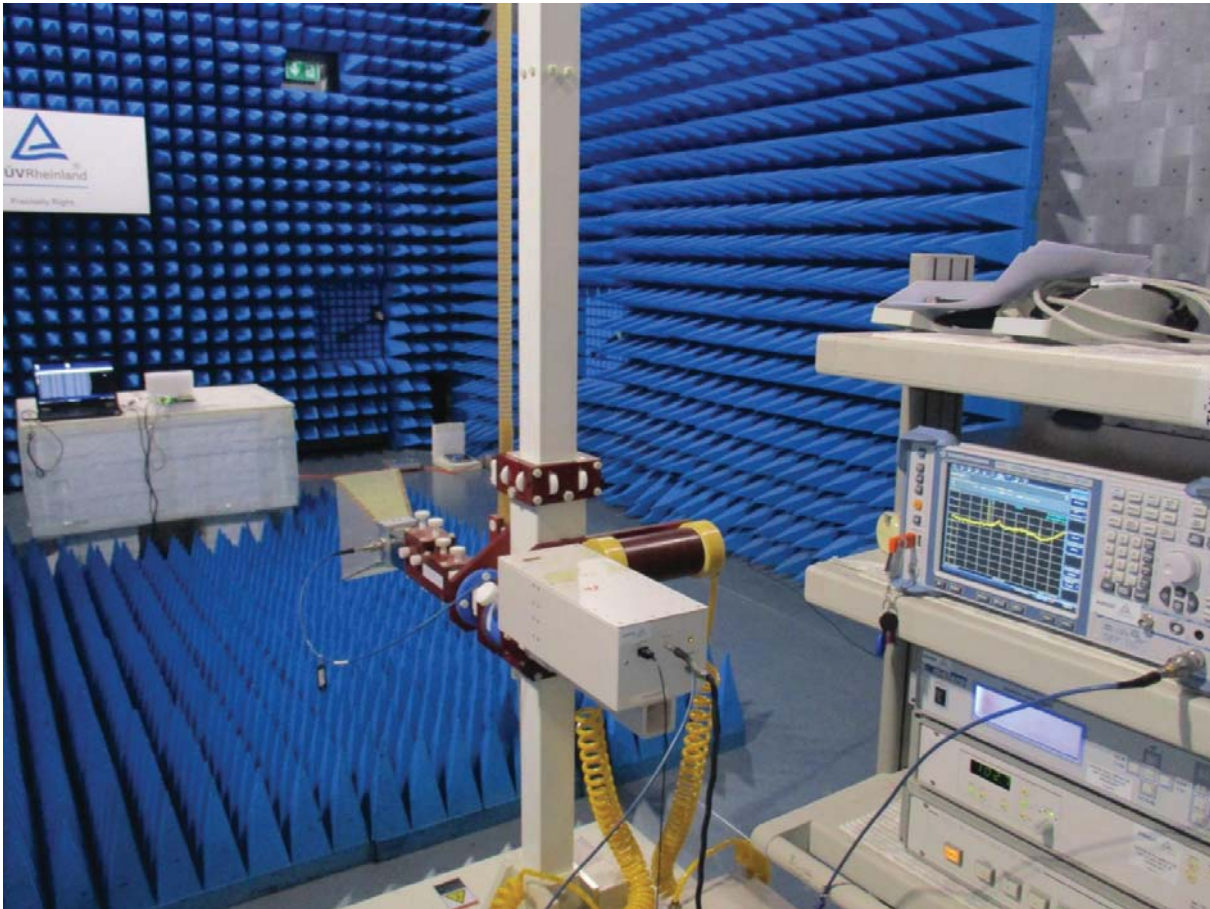
### 3.2.3 test setup 6-18 GHz

*Photo 3: Photograph radiated emissions 6 – 18 GHz*

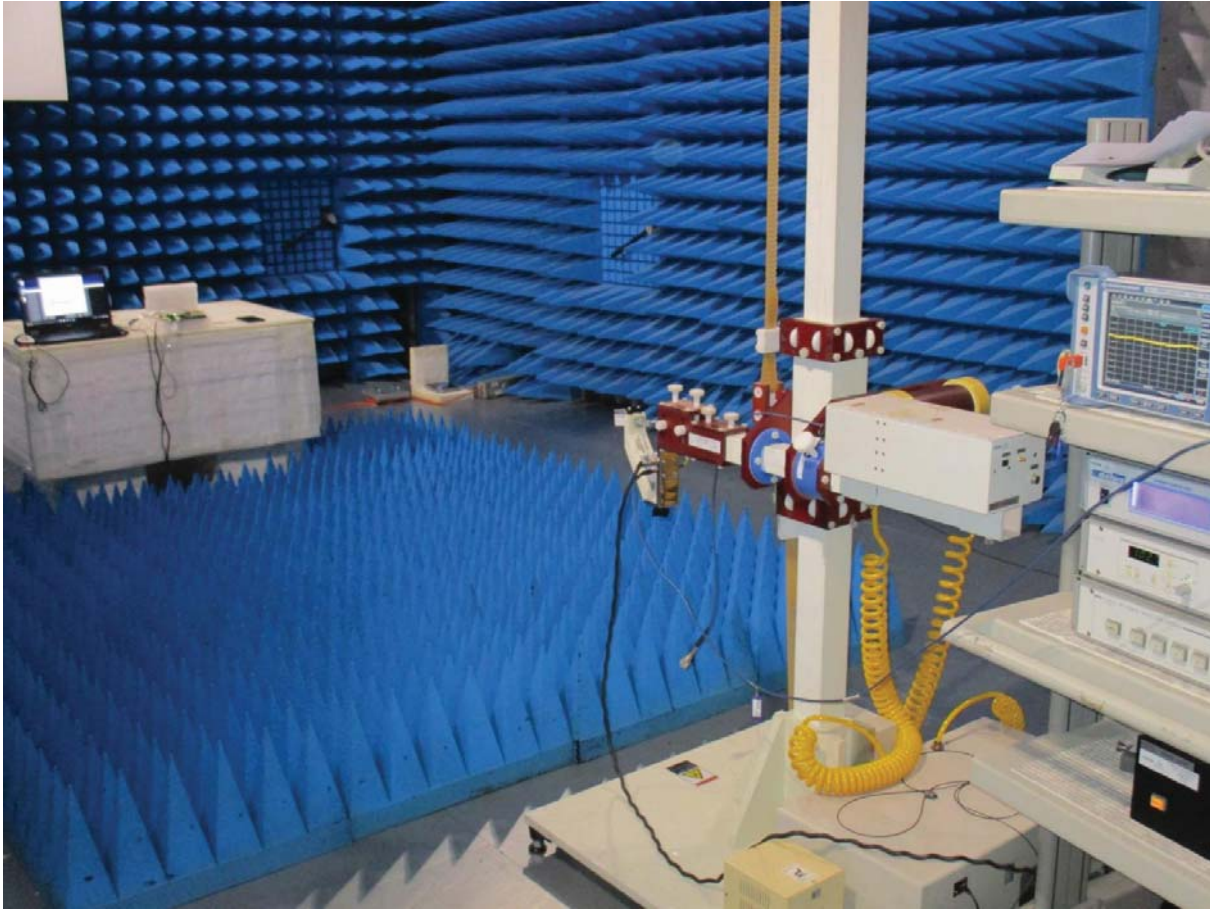
#### 3.2.4 test setup 18-30 GHz

*Photo 4: Photograph radiated emissions 18 – 30 GHz*
