# **MICROWAVE PATH SURVEY REPORT**

### **MEASUREMENT REPORT**

ViaSat

Des Moines (2G-14th Court), Iowa

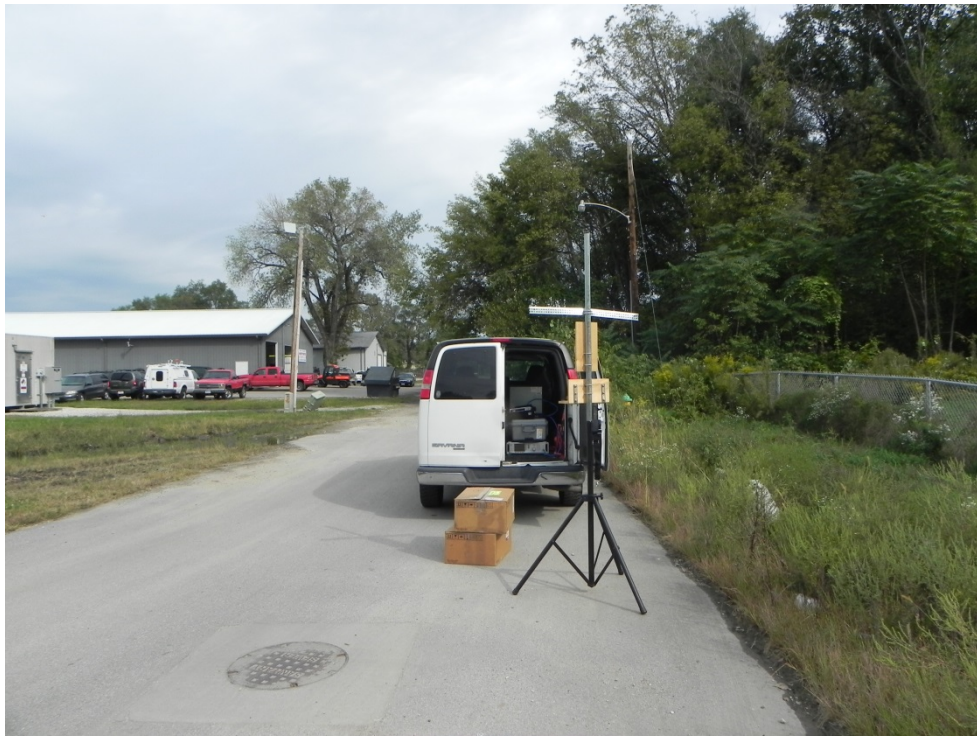
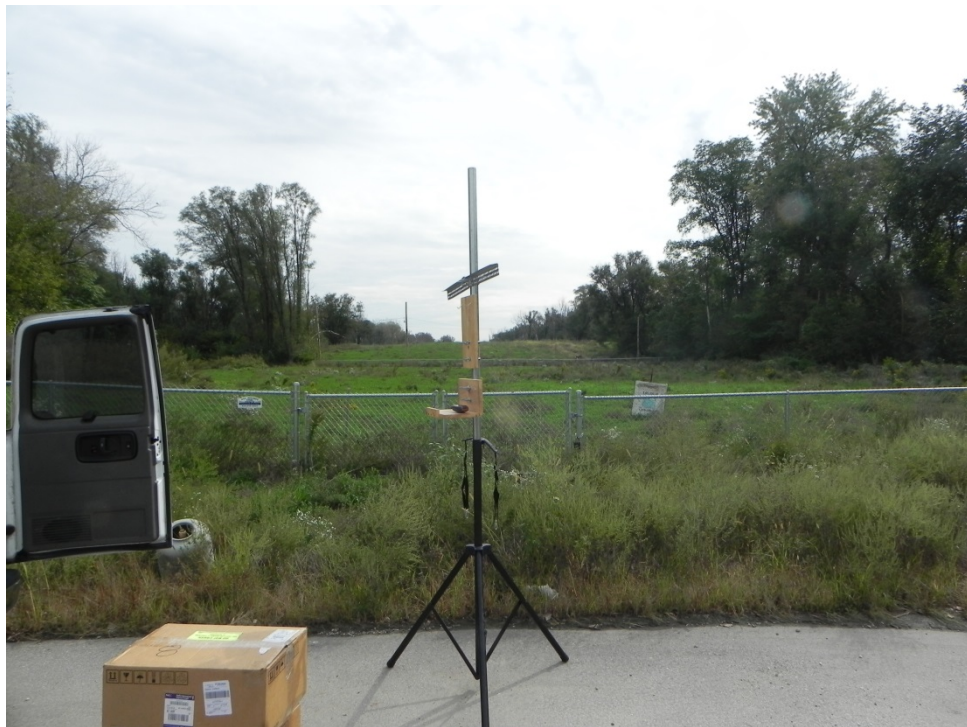
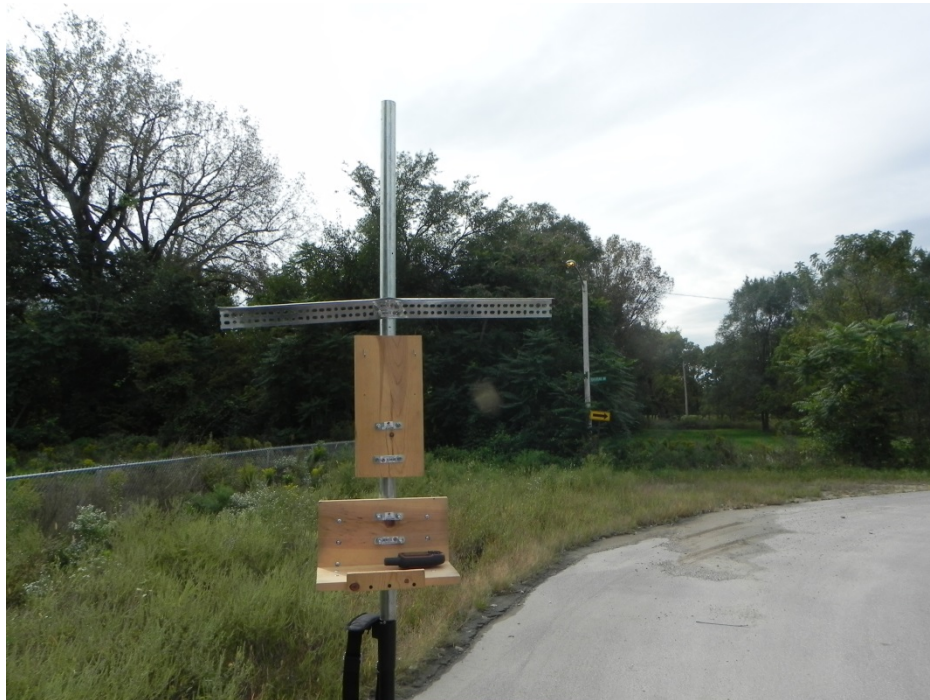
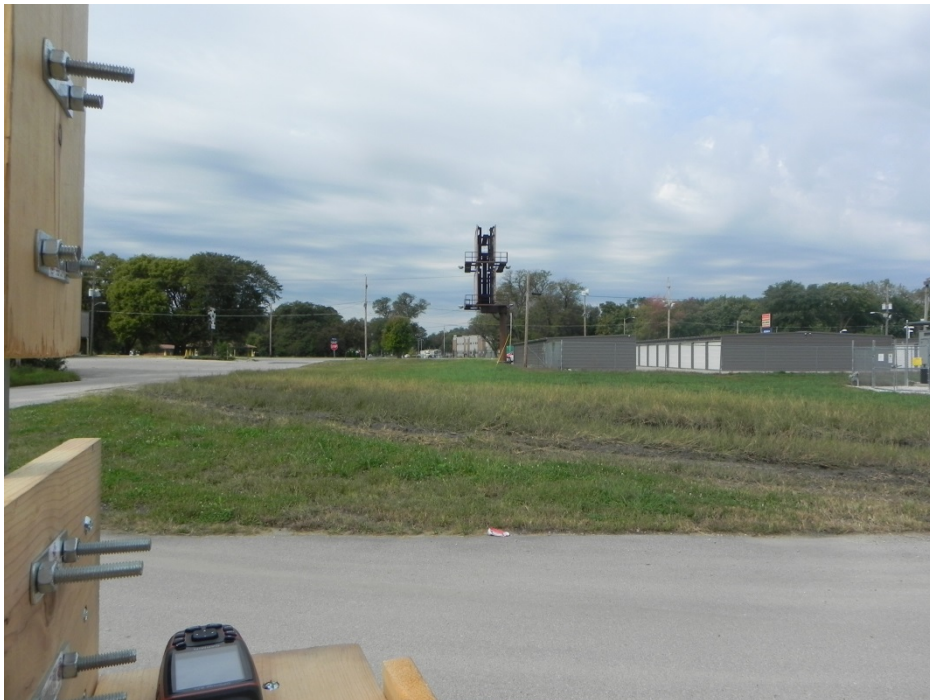
Figure 3.1-1 Earth Station Site Photographs

- Table 3.1-1 presents a site data sheet including all pertinent site information.
- Figures 3.1-1 and 3.1-2 are the photographs depicting the existing earth station site and satellite arc.
- Figures 3.1-3 through 3.1-10 are the RF spectrum photographs depicting the interference environment at the test site.

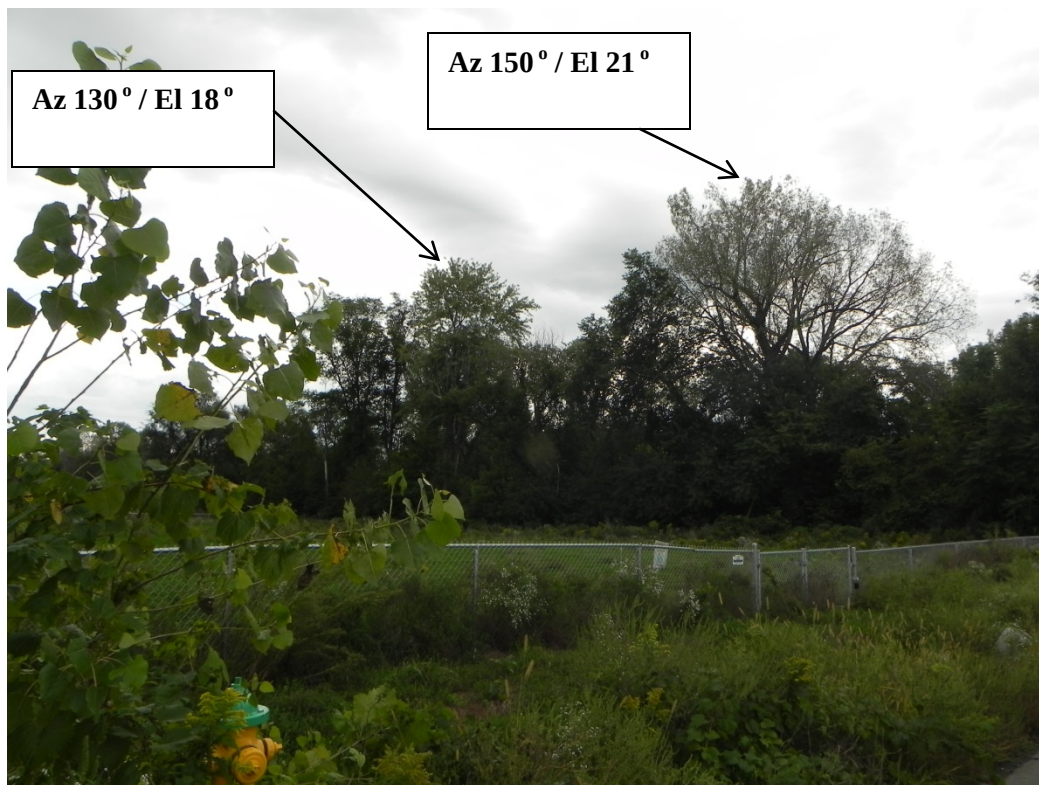
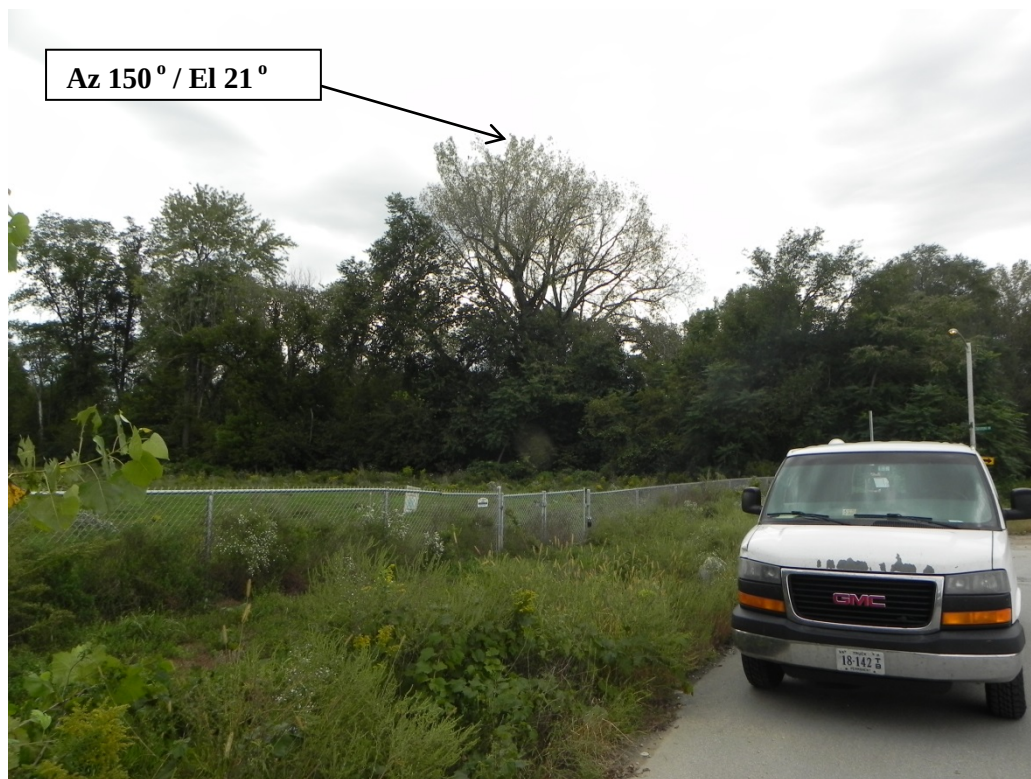
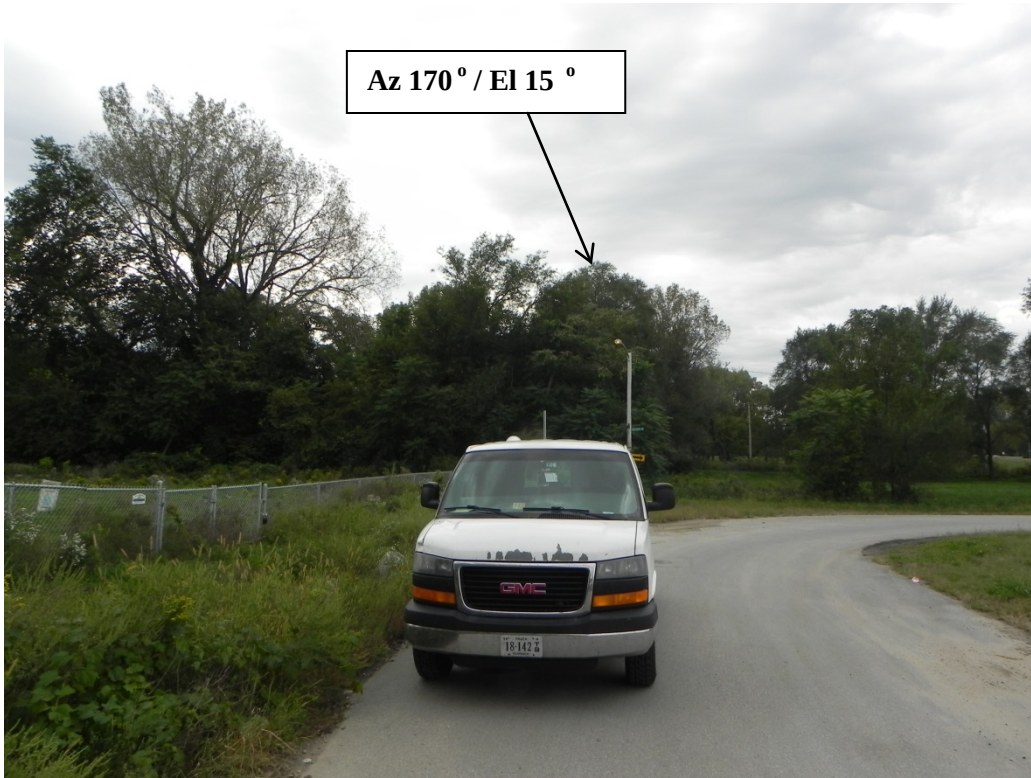
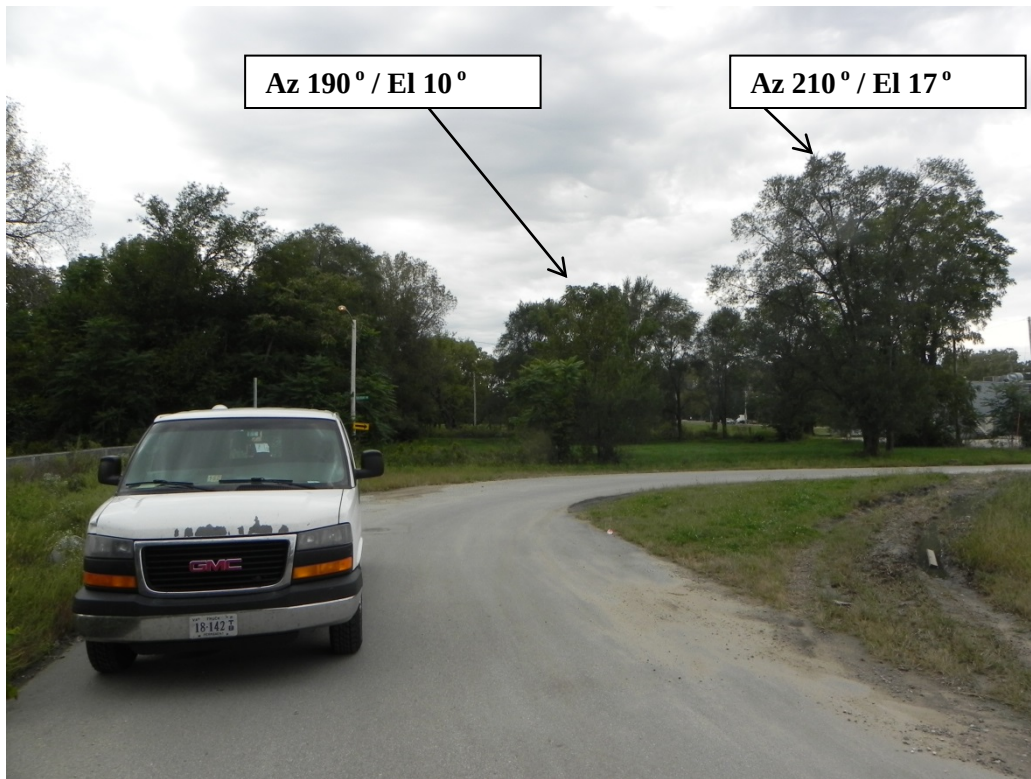
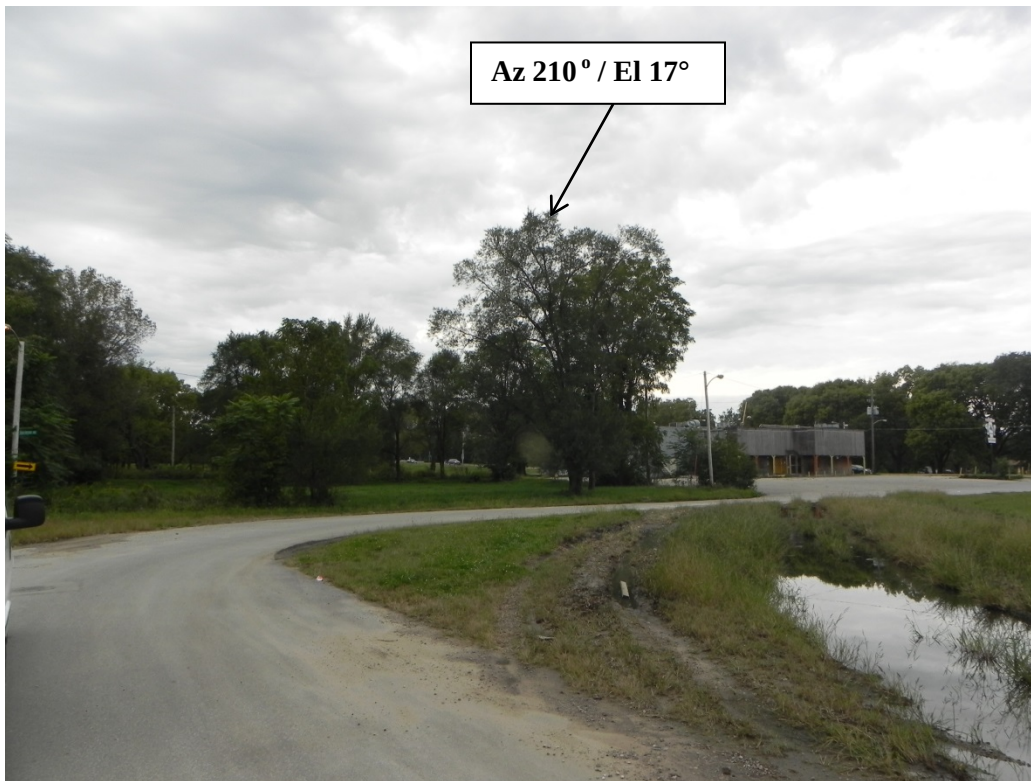
Figure 3.1-2 Horizon Photographs of Earth Station Site

There is no potential satellite arc blockage at this site. Final arc clearance will depend on antenna placement.

NOTE: Location in the design was not accessible for this test due to dense tree growth and high weeds. A location on the nearest road adjacent to the lot was used and is represented in the overhead view as a push pin. To determine the arc clearances a spot at the same setback as the design on the lot was used on the adjacent road. Elevations are based on that information.

The satellite arc has no potential blockage from 55W through 115W.
