# **MICROWAVE PATH SURVEY REPORT**

## **RADIO FREQUENCY INTERFERENCE (RFI) MEASUREMENT REPORT**

ViaSat

**Transmit and Receive Earth Station**  
17-21 GHz and 27-31 GHz

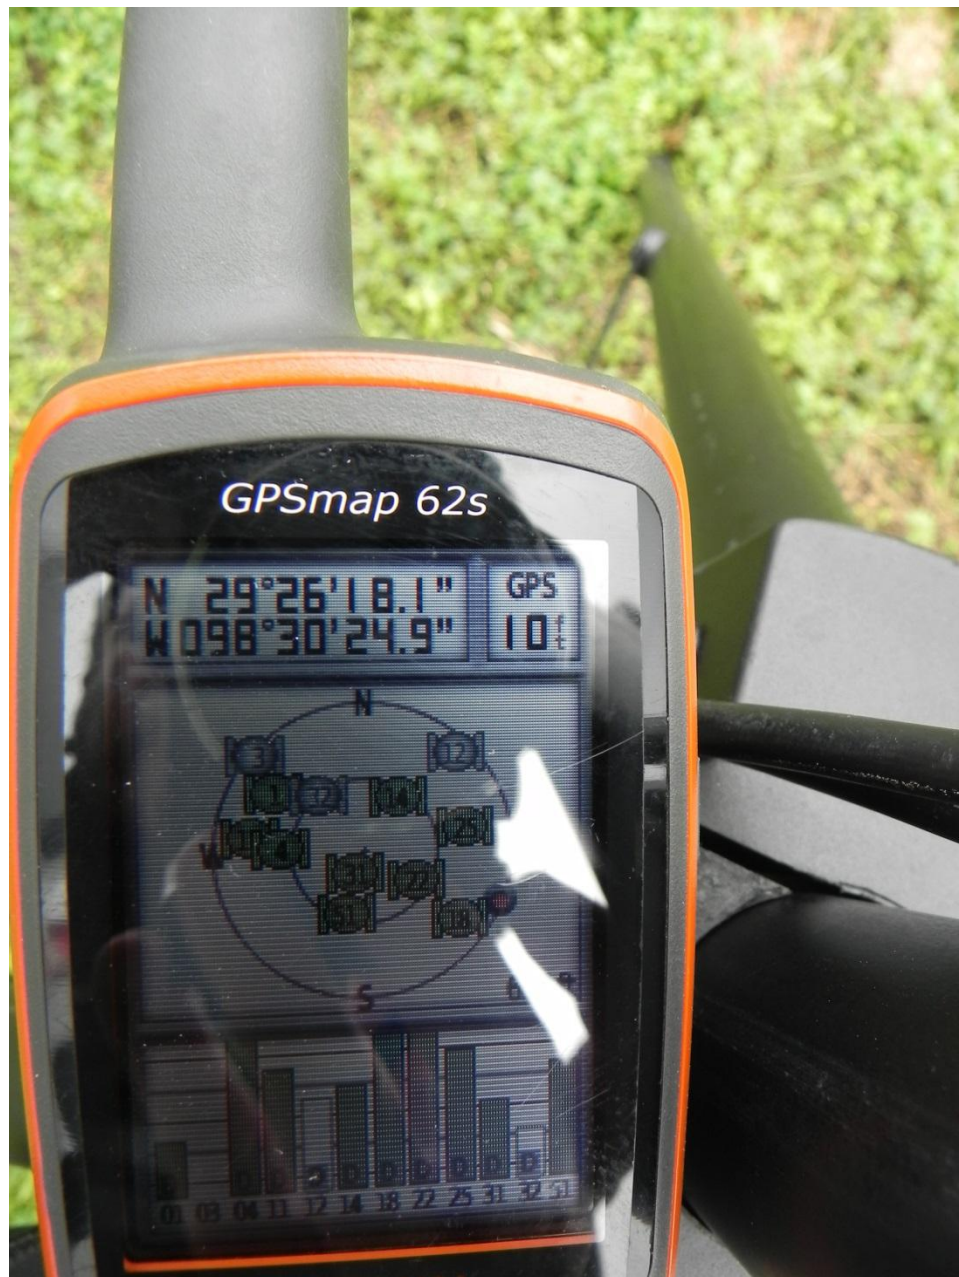
**Figure 1.2-3 – GPS Photograph**

The measured site is identified on a portion of a topographic map shown in Figure 1.2-1. An aerial photo of the site location is shown in Figure 1.2-2. A photo of the measurement using a GPS is shown in Figure 1.2-3.

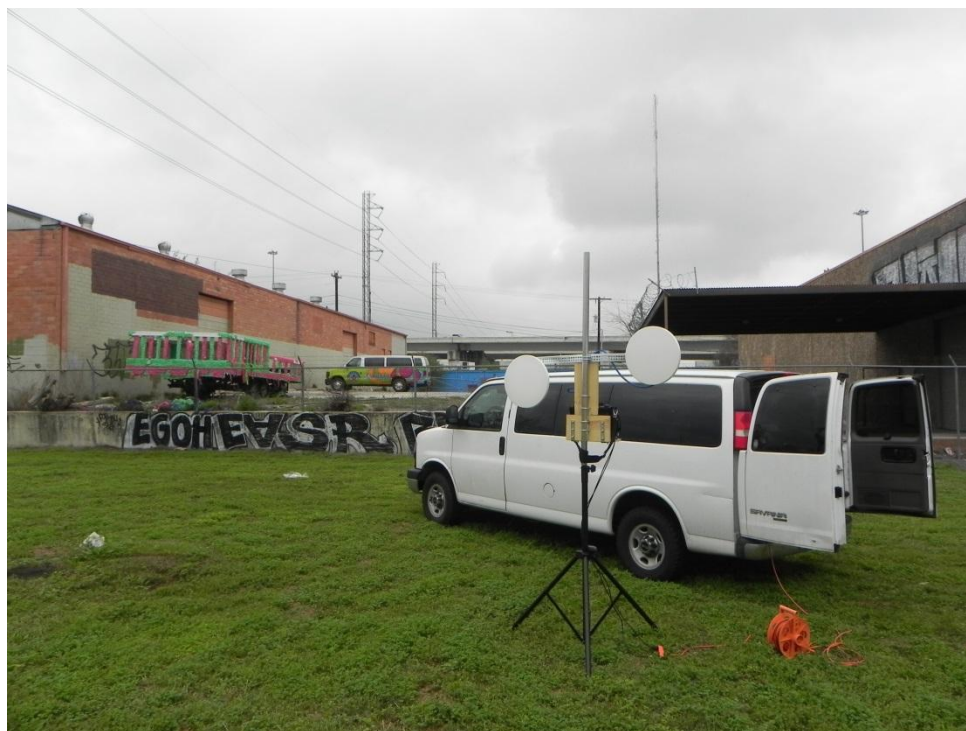
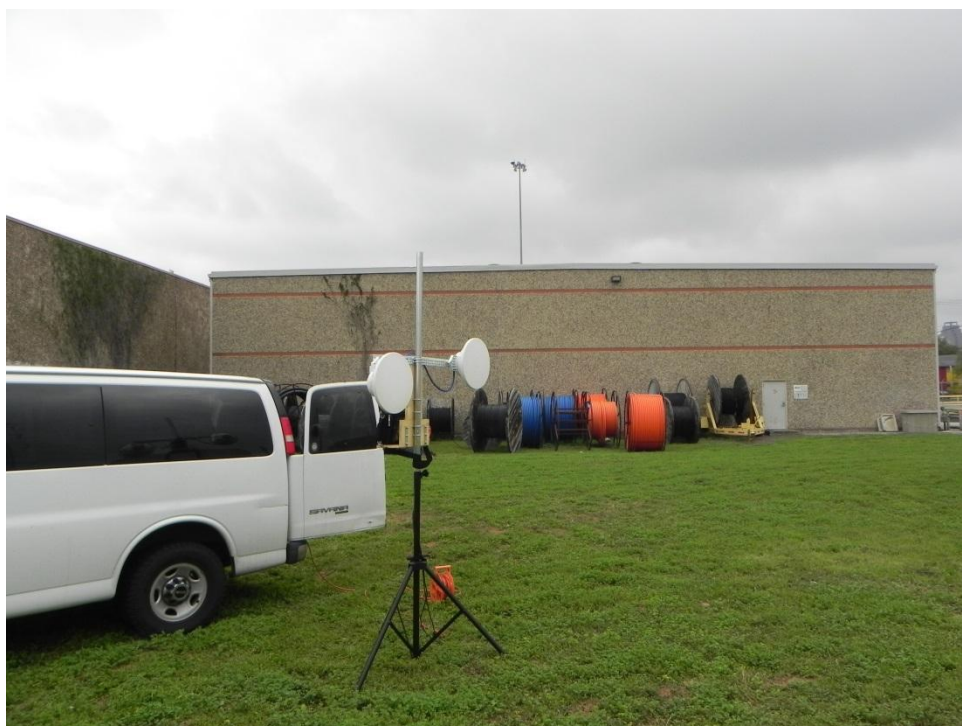
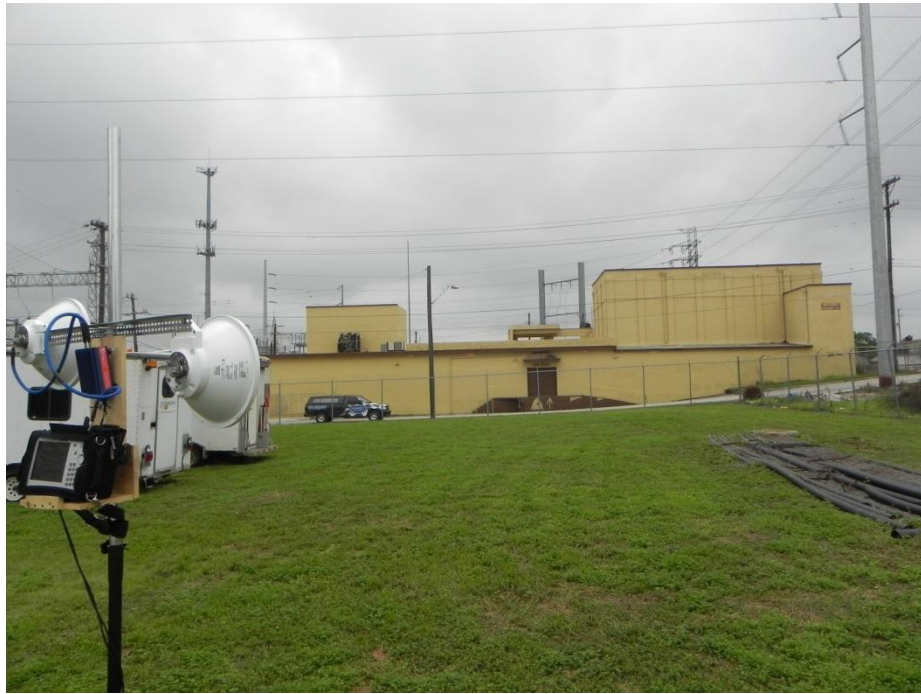
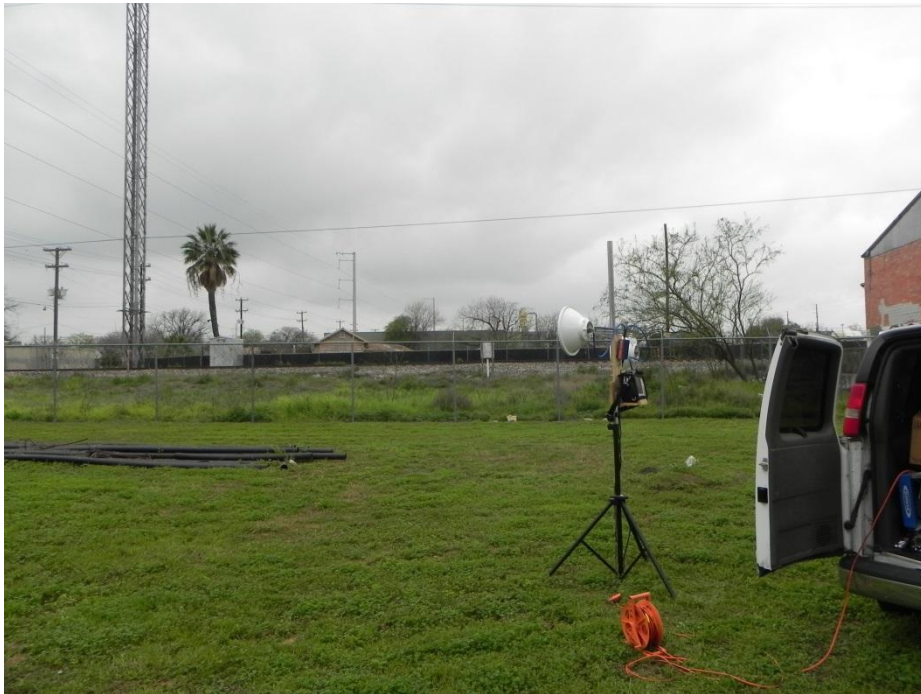
Figure 3.1-1 Earth Station Site Photographs

- Table 3.1-1 presents a site data sheet including all pertinent site information.
- Figures 3.1-1 and 3.1-2 are the photographs depicting the existing earth station site and satellite arc.
- Figures 3.1-3 through 3.1-10 are the RF spectrum photographs depicting the interference environment at the test site.

| 8. GEOSTATIONARY ARC VISIBILITY: | Satellite arc has no blockage at this time |

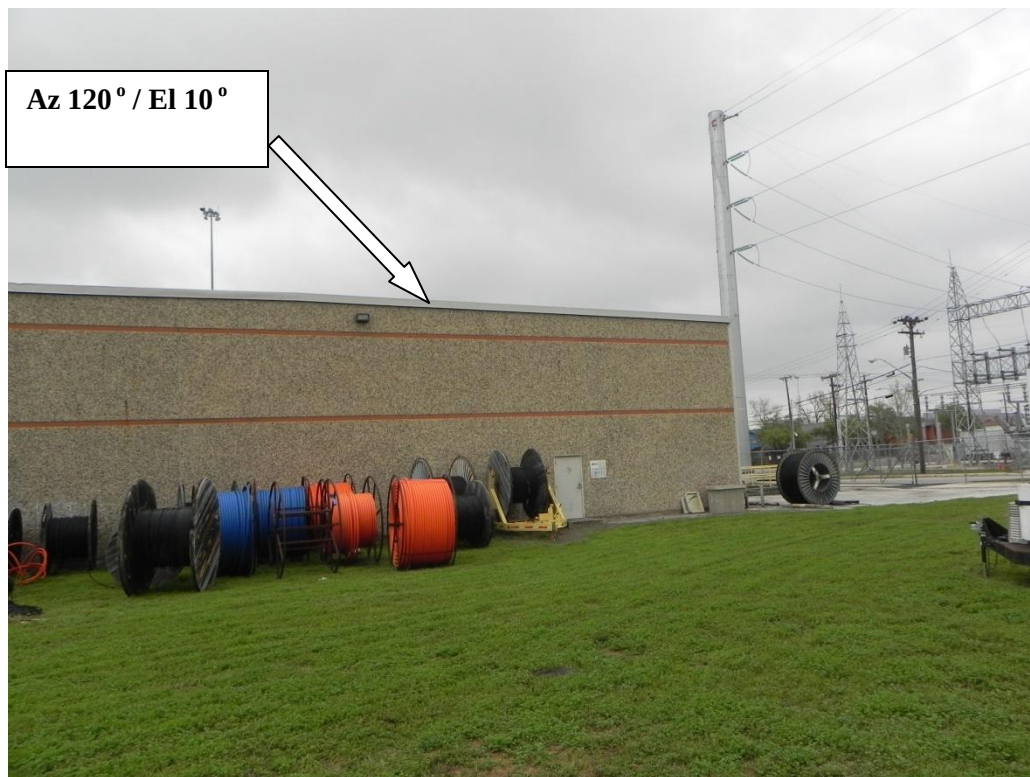
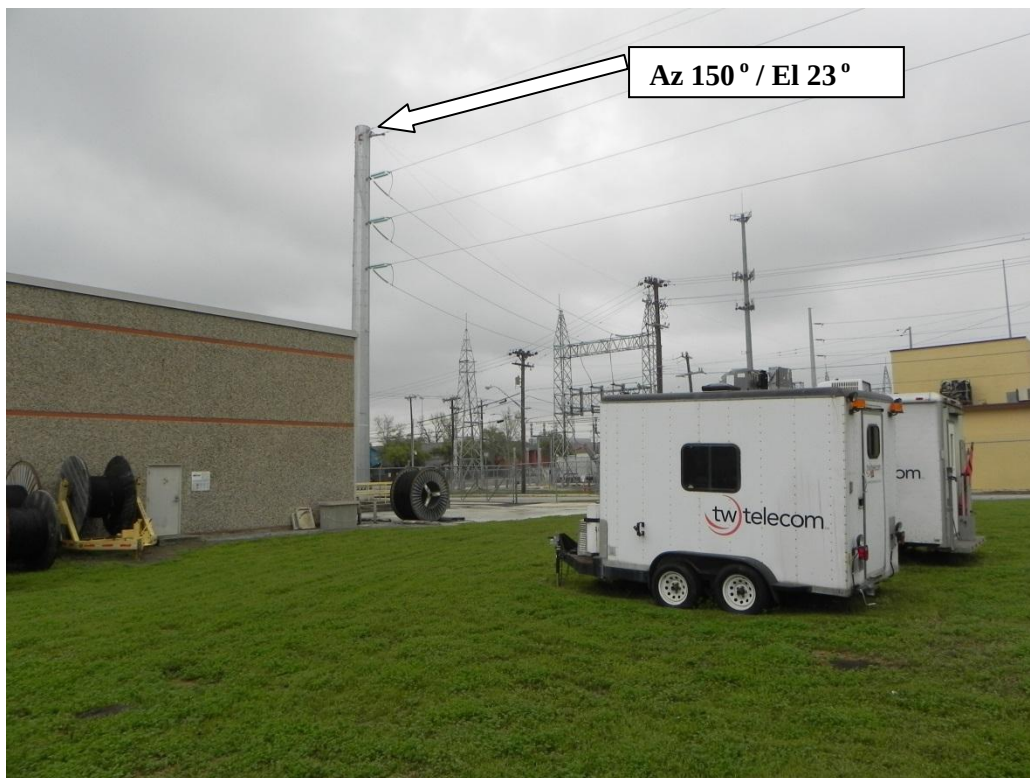
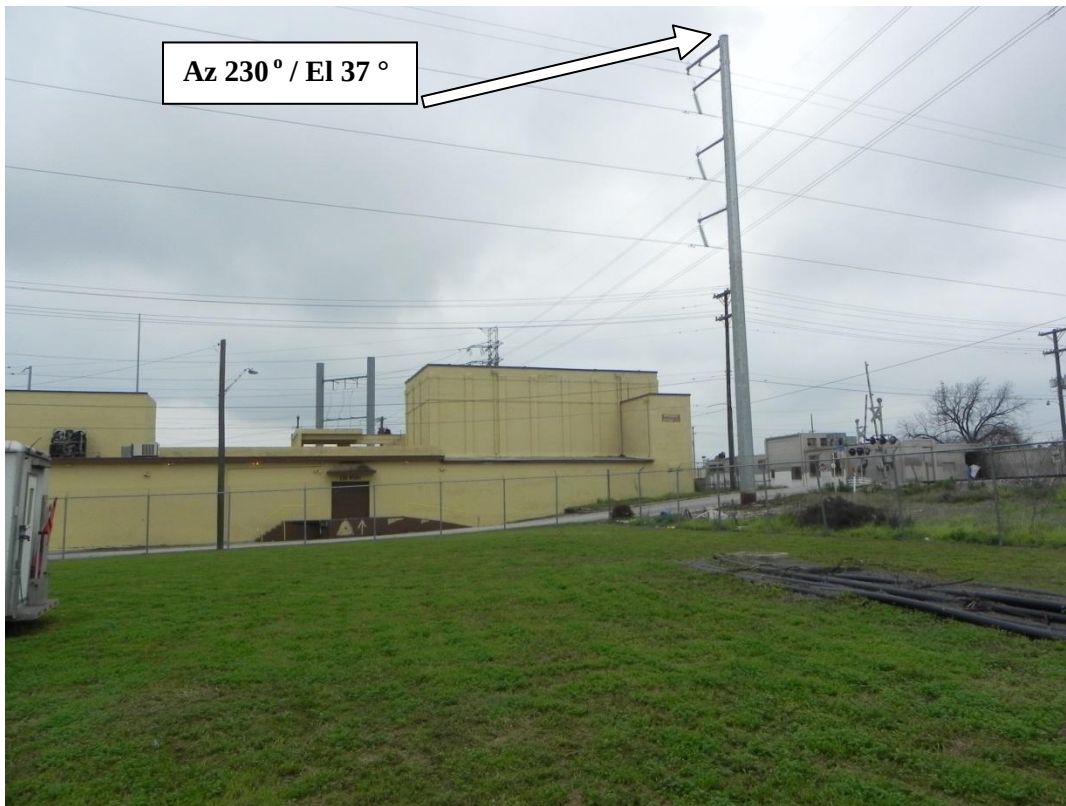
Figure 3.1-2 Horizon Photographs of Earth Station Site

There is no potential satellite arc blockage at this site. Final arc clearance will depend on antenna placement.

The satellite arc has no potential blockage from 55W through 115W.
