**Exhibit 7B MPE Test Report Photographs****Motorola Solutions Inc.****EME Test Laboratory**

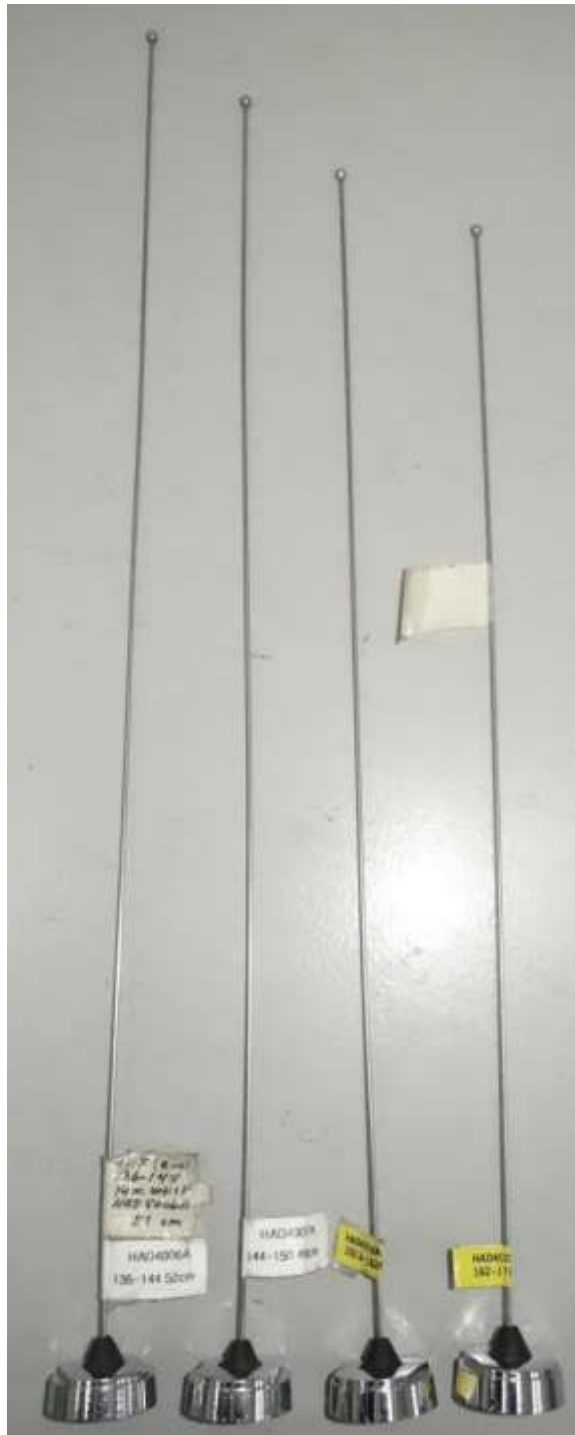
**VHF Antenna kit numbers, from left to right  
HAD4006A, HAD4007A, HAD4008A, HAD4009A**

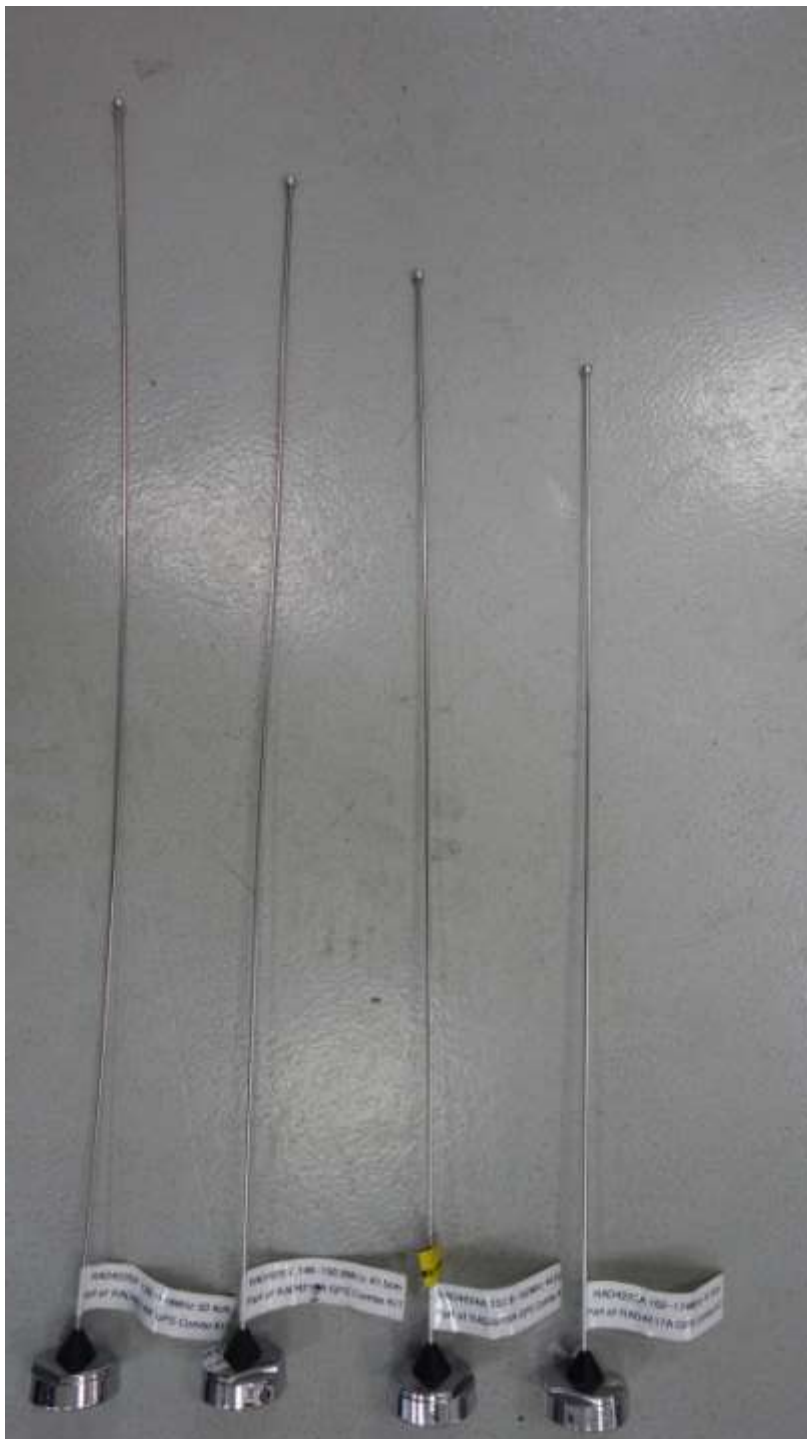
**VHF Antenna kit numbers, from left to right  
RAD4226A, RAD4227A, RAD4224A, RAD4223A**

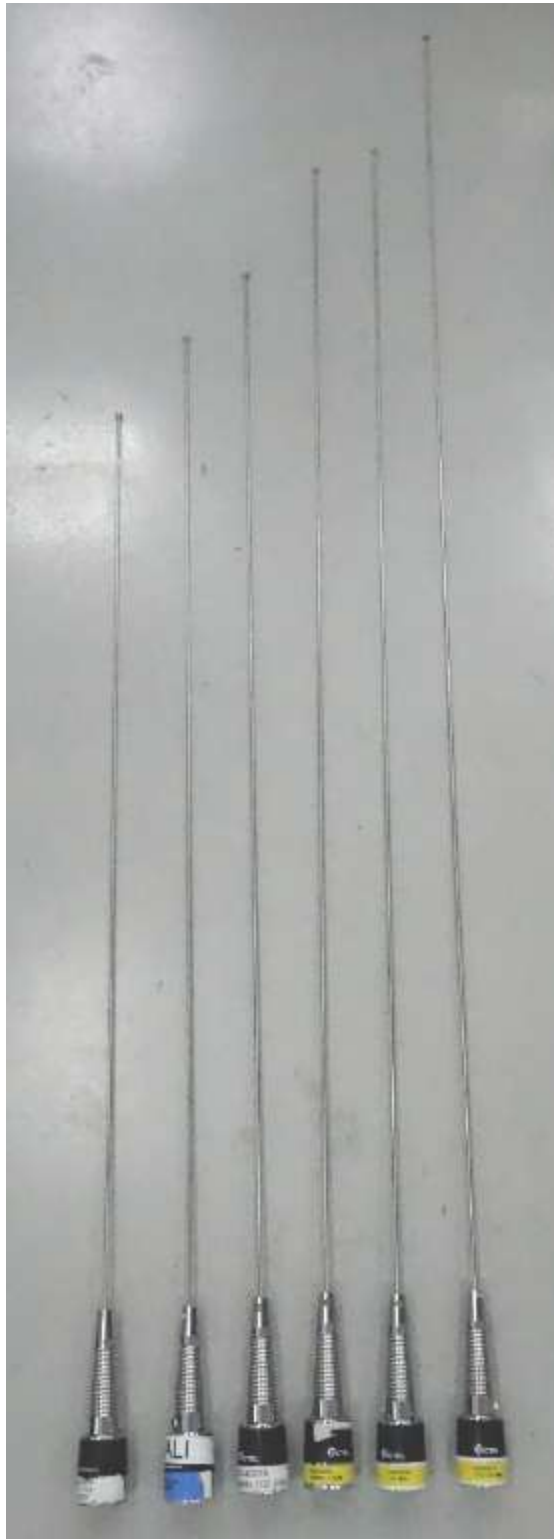
**VHF Antenna kit numbers**  
HAD4022A (6 pcs)

Note: Antenna length trimmed to frequency.

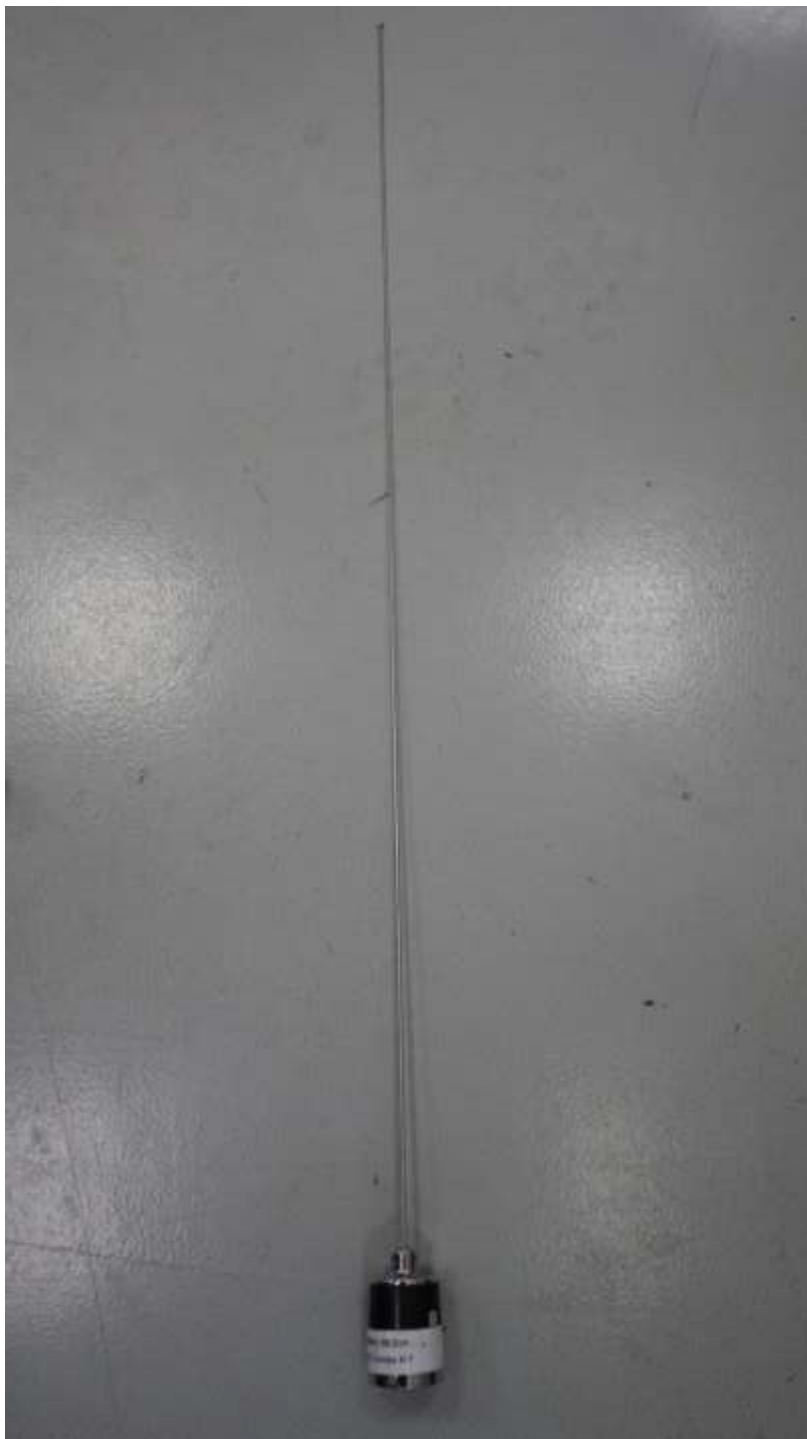
**VHF Antenna kit numbers**  
RAD4225A

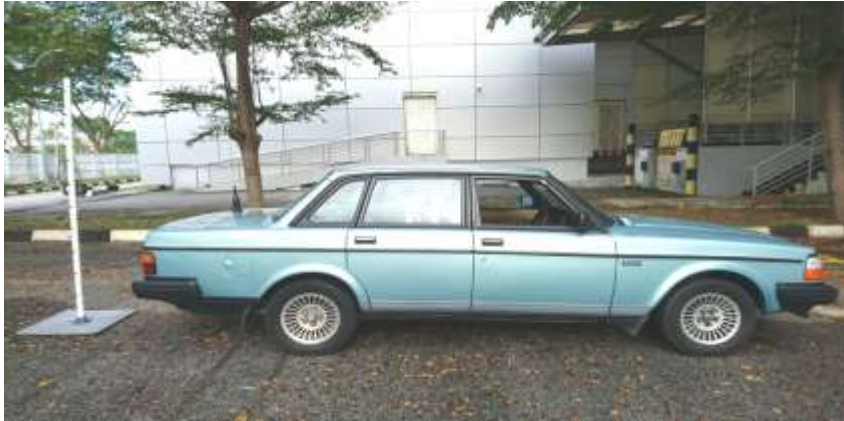
Test measurement setup for Bystander, trunk mount antenna behind vehicle

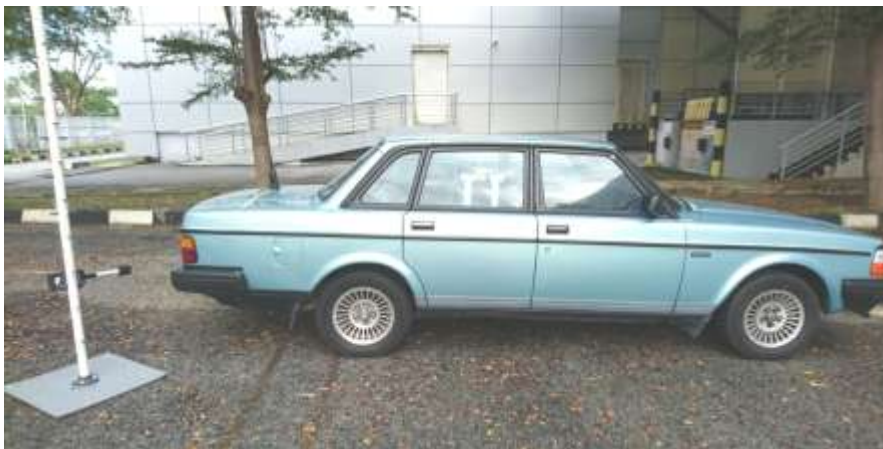
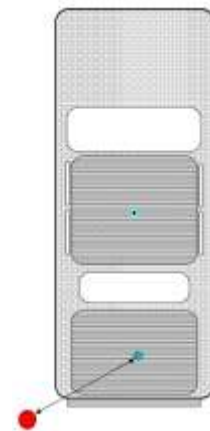
Test measurement setup for Bystander 45 degree (diagonal) trunk mount antenna

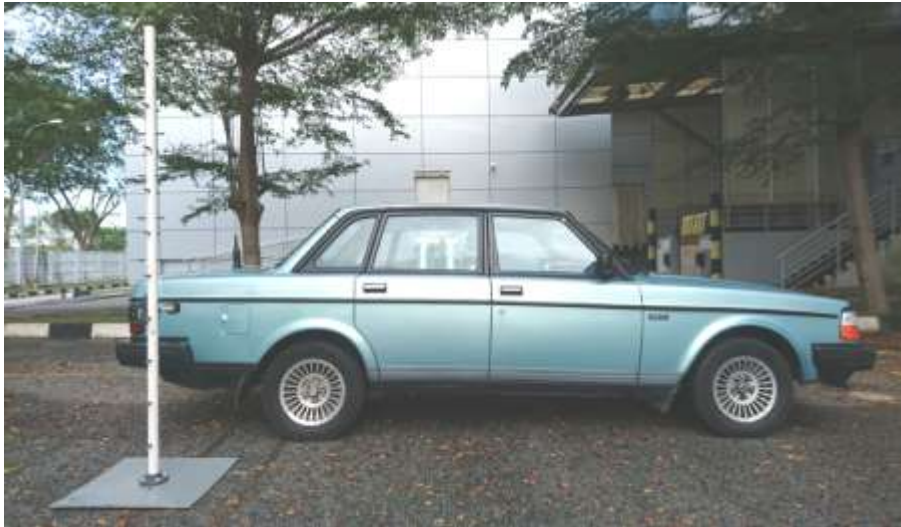
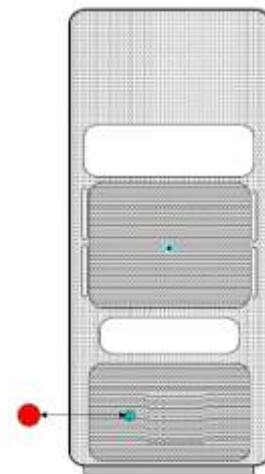
Test measurement setup for Bystander 90 degree (side) trunk mount antenna

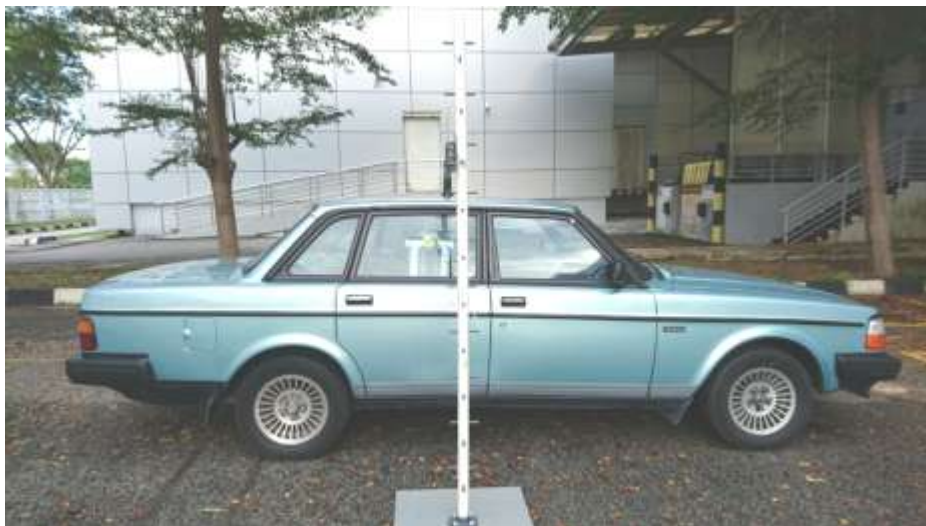
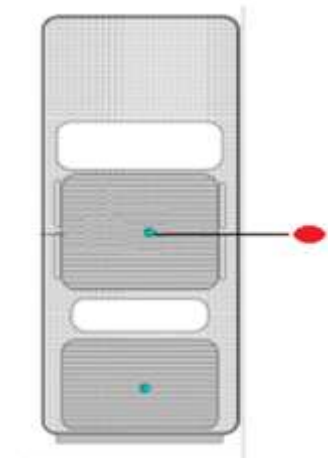
Test measurement setup for Bystander roof mount antenna

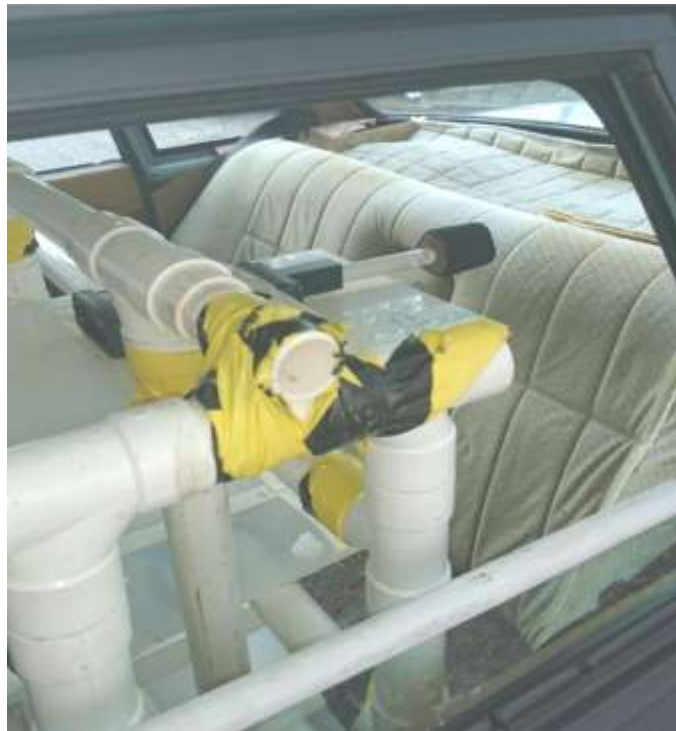
Test measurement setup for Passenger Back

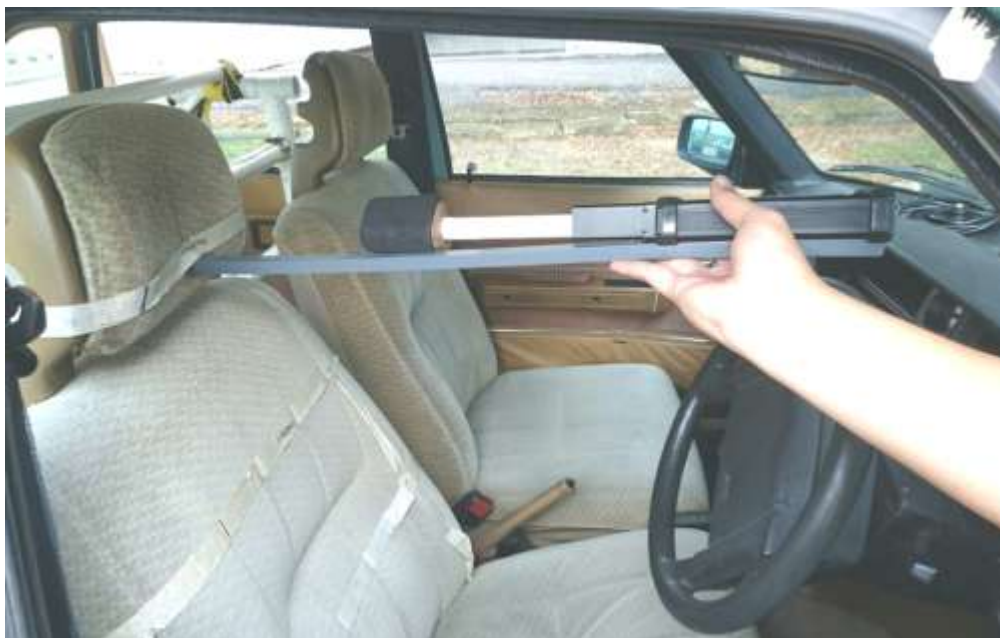
Test measurement setup for Passenger Front

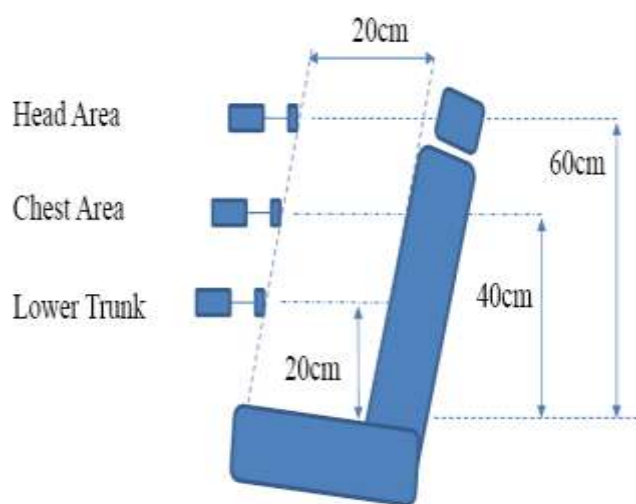
Test positions for Passenger Back and Front

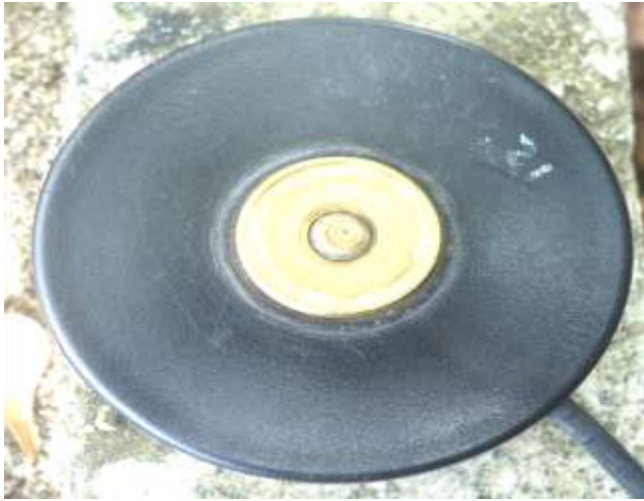
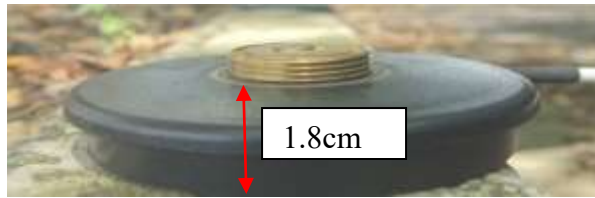
**Magnetic mount base (top and side view)**
